**Storm Water Source Control Evaluation  
Operable Unit 3  
Swan Island Upland Facility  
Portland, Oregon**

**Prepared for:  
Port of Portland**

**March 10, 2010  
1115-08**

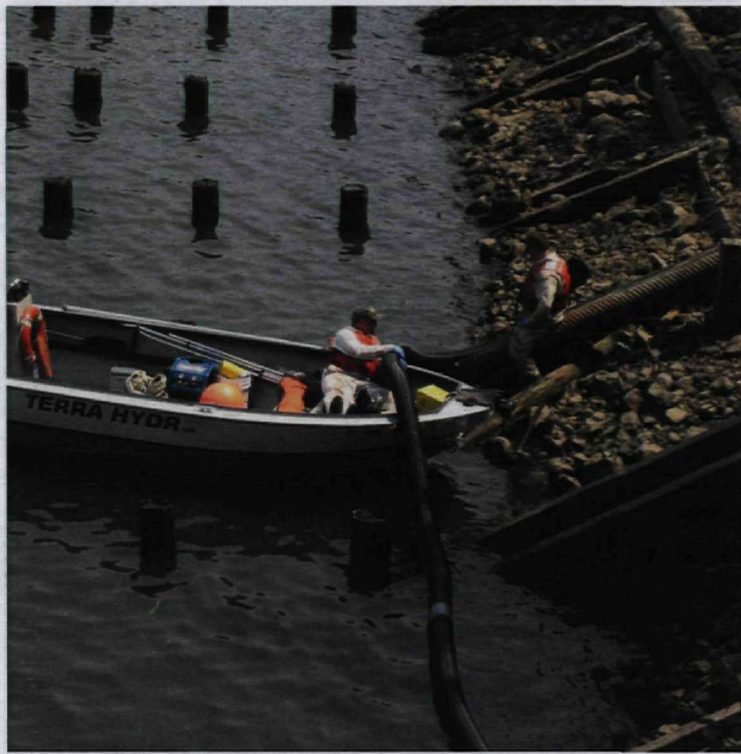
<b>Photo No:</b> 3

<b>Photo Date:</b> 7/21/2008	
<b>Orientation:</b> Southwest	
<b>Description:</b>  Example of the 10-inch corrugated metal pipes that discharge to the Swan Island Lagoon.  Cleanout of the outfall pipes conducted by boat from the Swan Island Lagoon.

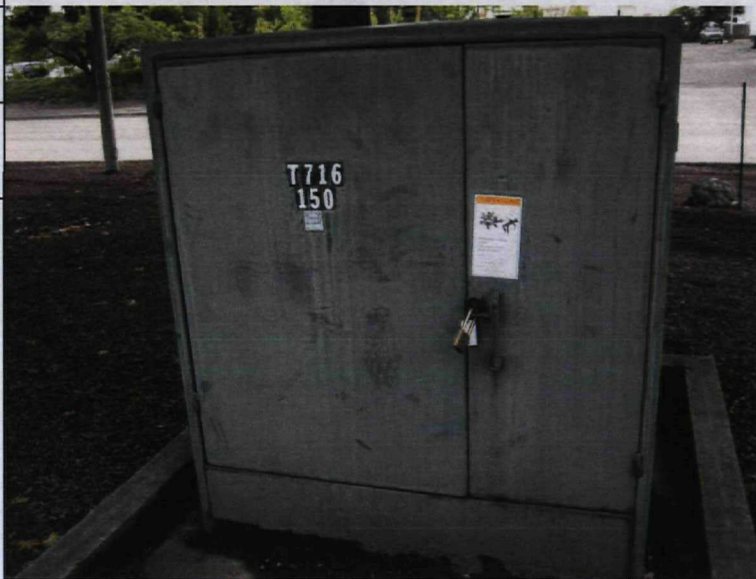
<b>Photo No:</b> 4	
<b>Photo Date:</b> 9/22/2008	
<b>Orientation:</b> South	
<b>Description:</b>  Non-PCB transformer present on the Facility.

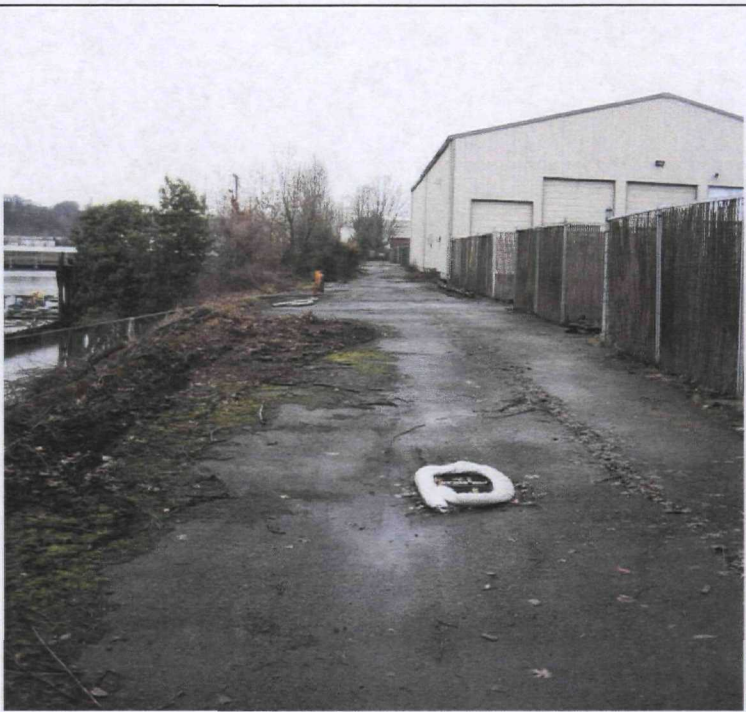
<b>Photo No:</b> 7

<b>Photo Date:</b> 3/14/2009	
<b>Orientation:</b> Southwest	
<b>Description:</b>  Vegetation/moss on the asphalt-concrete surface along the top of the riverbank before the surface cleanup. Inlet WR-034 is near the center of the photo.  Absorbent sock was maintained by former tenant as part of SPCC Plan.	
<b>Photo No:</b> 8

surround each storm water inlet (Photograph 7). The daily and weekly inspection checklists included in the Freightliner SPCC Plan included observations of the absorbent booms. Freightliner indicated that the boom material was replaced on an as-needed/annual basis. A spill containment kit was available in the shop area (Photograph 5), and Freightliner implemented an employee awareness and training program.

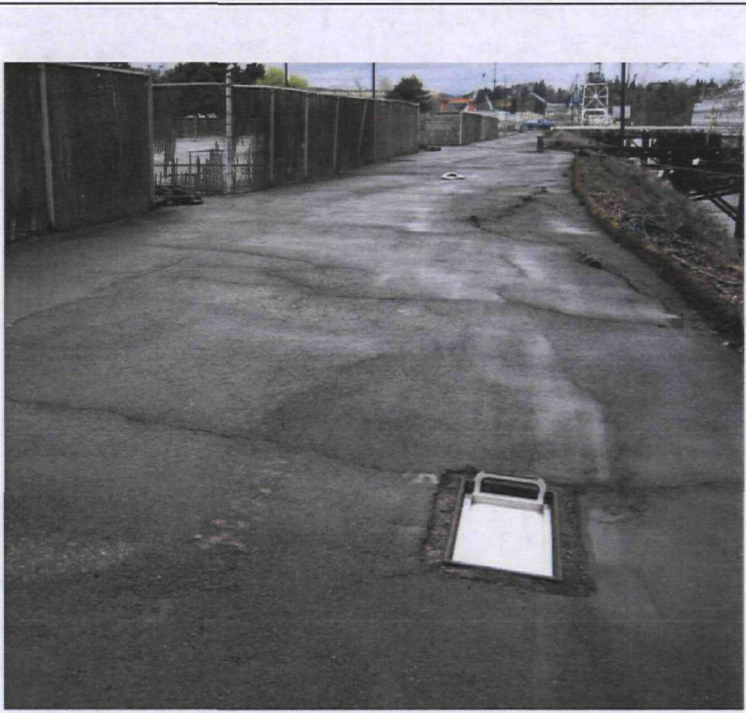
<b>Photo Date:</b> 4/12/2009	
<b>Orientation:</b> Northwest	
<b>Description:</b>  Inlet WR-034 area after surface cleanup with storm water sampling pan installed.  Absorbent sock was replaced after sampling.

A stainless steel storm water sampling pan was constructed to allow for sample collection (Photograph 8). The decontaminated sampling pans were deployed after removing the grated inlet covers. Samples were collected with a disposable polyethylene bottle and transferred into large, pre-cleaned bulk sample containers (with the exception of TPH as gasoline [TPHg] where VOA vials were directly filled from the disposable polyethylene bottle). The laboratory split the samples into the required volumes for analysis, filtering where applicable.

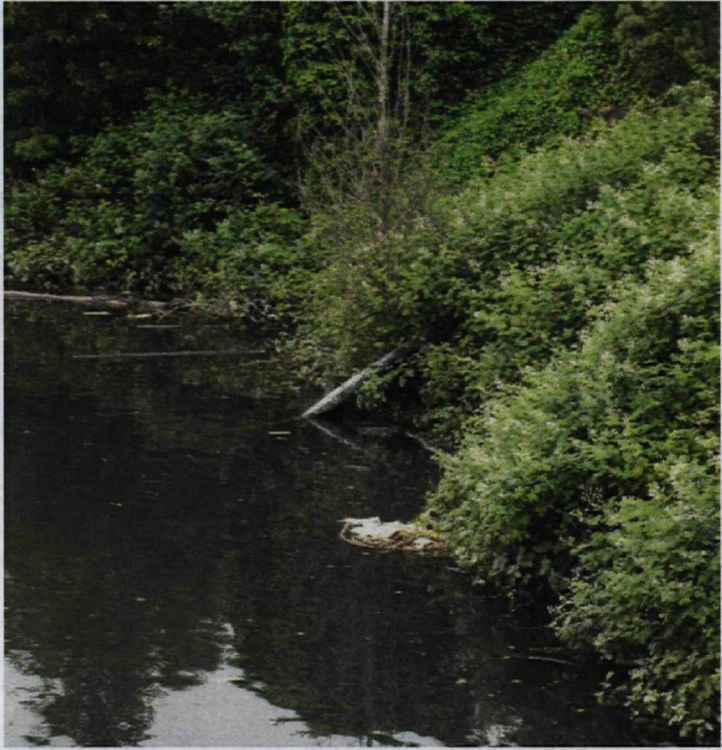
<b>Photo No:</b> 9

<b>Photo Date:</b> 6/10/2008	
<b>Orientation:</b> Southeast	
<b>Description:</b>  Storm water outfall submerged in Sawn Island Lagoon.	
<b>Photo No:</b> 10

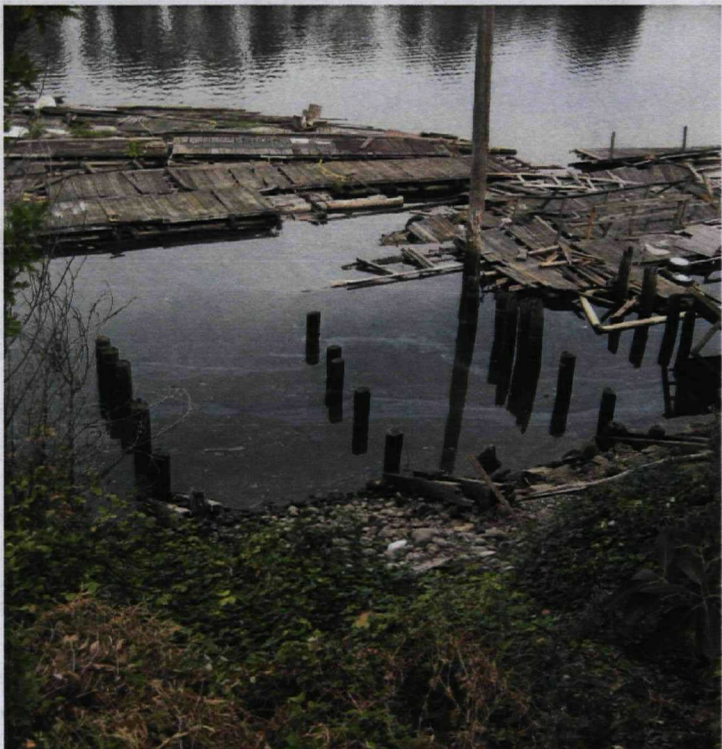
**Shoreline Monitoring.** Because of the limited inflows and essentially no current, the Lagoon acts as a collection point for floating debris and sheen. A sheen on the Lagoon was observed adjacent to the Facility during a Port/DEQ site visit conducted in November 2007. As discussed in the Port's June 30, 2008 letter to the DEQ, there was no indication that the sheen originated at the Facility, nor was it confirmed that the sheen was of hydrocarbon origin. It is more likely that the sheen was due to releases from ship traffic, other more significant storm water discharges, or the presence of naturally occurring organics in the Lagoon. A minor sheen was observed on the water at the southern end of the Facility during a Port/DEQ site visit conducted on October 1, 2008 (Appendix A, Photograph 10). The sheen was floating offshore adjacent to other debris that had accumulated in the Lagoon below the OLHW. It was not discernable whether the sheen was related to naturally occurring organics or the presence of hydrocarbons.

<b>Photo Date:</b> 10/1/2008	
<b>Orientation:</b> Northeast	
<b>Description:</b>  Floating debris and sheen observed on surface water at the southern end of the Facility.

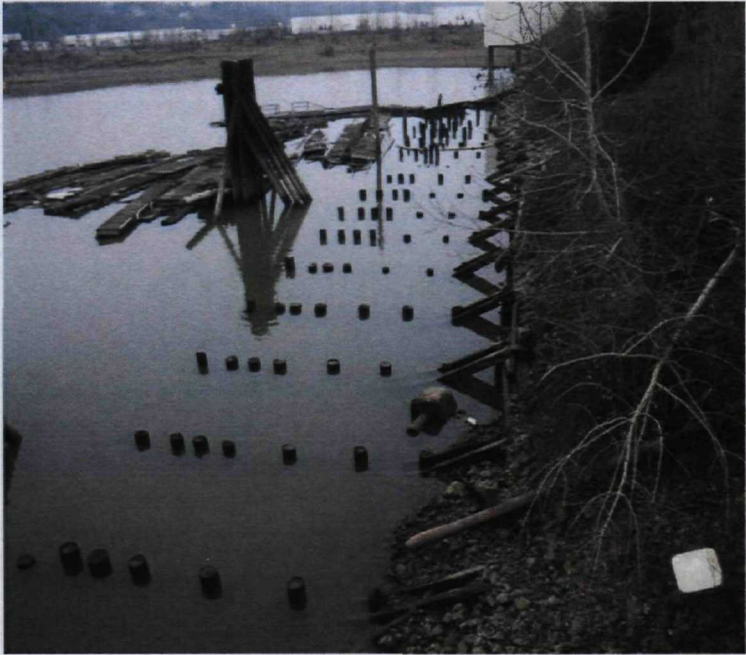
<b>Photo No:</b> 11

Monthly monitoring of the shoreline was conducted during the period of storm water sampling (January through April 2009) to assess for potential sheen associated with the Facility. No sheen was observed (Appendix A, Photographs 11 through 14).

<b>Photo Date:</b> 1/30/2009	
<b>Orientation:</b> Southeast	
<b>Description:</b>  Photograph of southern end of Facility – no sheen observed.	
<b>Photo No:</b> 12

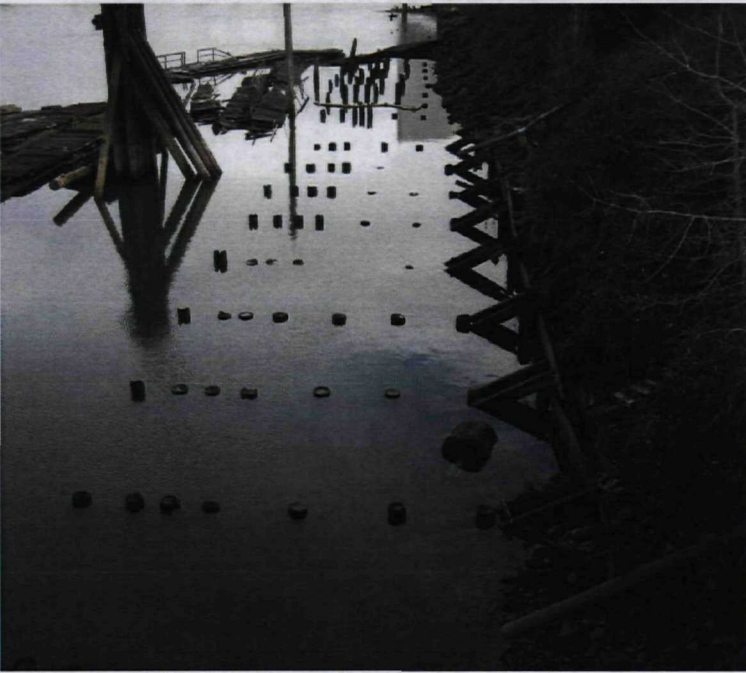
<b>Photo Date:</b> 2/24/2009	
<b>Orientation:</b> Northeast	
<b>Description:</b>  Photograph of southern end of Facility – no sheen observed.

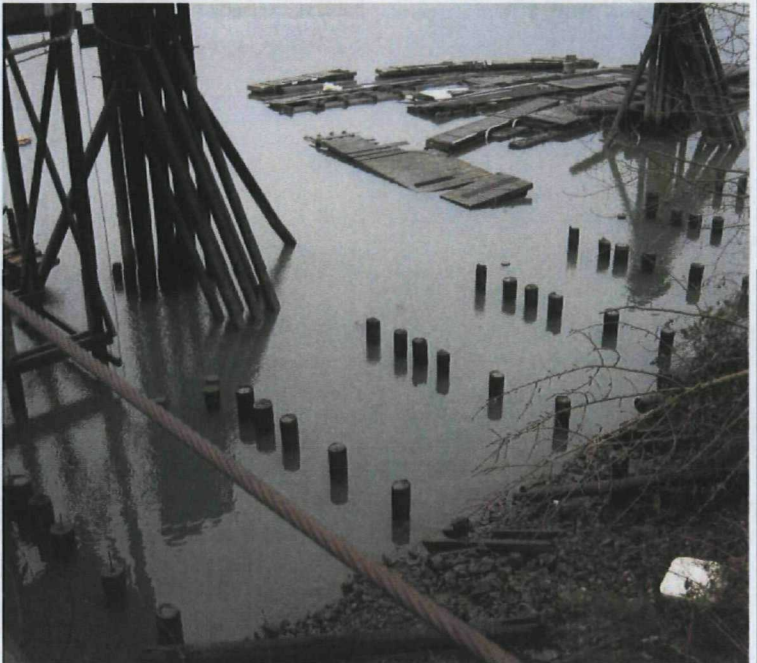
<b>Photo No:</b> 13

<b>Photo Date:</b> 3/14/2009	
<b>Orientation:</b> Southeast	
<b>Description:</b>  Photograph of southern end of Facility – no sheen observed.	
<b>Photo No:</b> 14

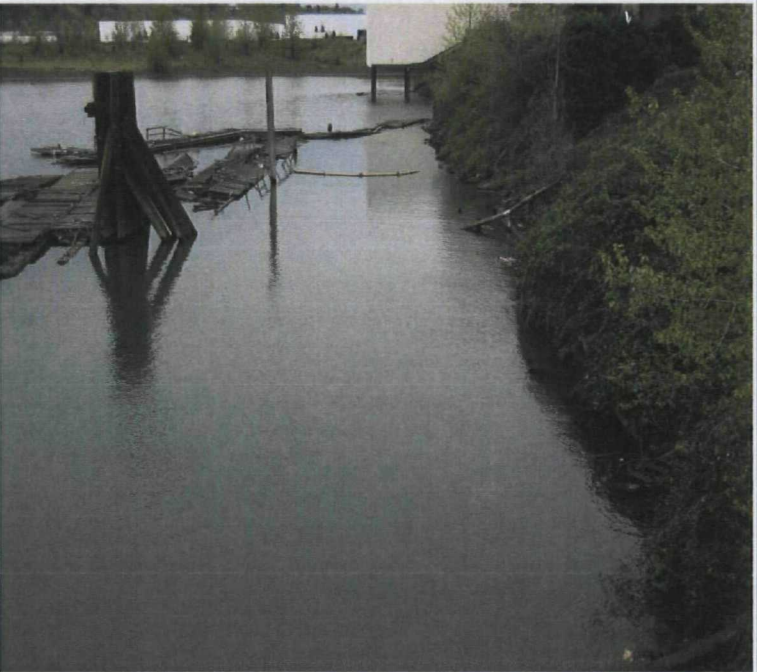
<b>Photo Date:</b> 4/12/2009	
<b>Orientation:</b> Southeast	
<b>Description:</b>  Photograph of southern end of Facility – no sheen observed.
